MISCELLANEOUS PAPER SL-81-9

# DETERIORATION AND REPAIR OF CONCRETE IN THE LOWER MONUMENTAL NAVIGATION LOCK WALL

Ernest K. Schrader

June 1981

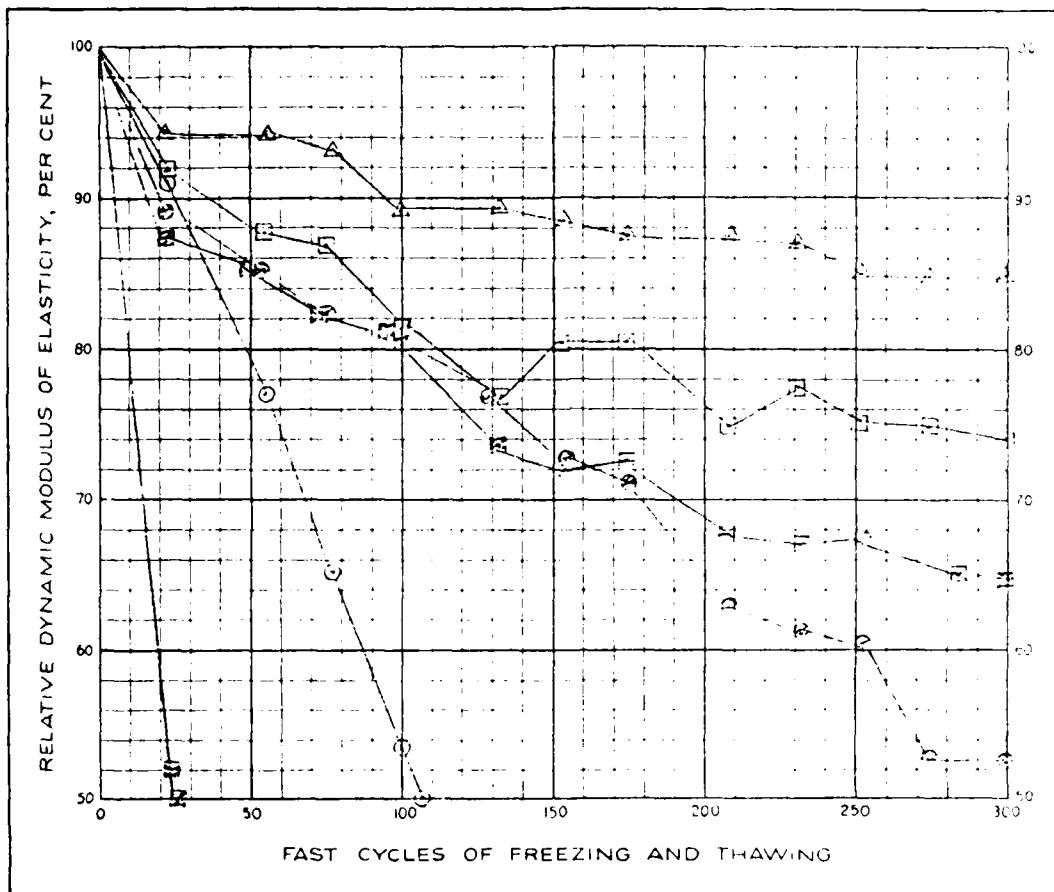
BEAM NO	SYMBOL	DIE AT 300 CYCLES	NO CYCLES REL E = 50%	PROJECT
1-1	⊙	17.8	107	LOWER MONUMENTAL NAVIGATION LOCK REPAIR
1-2	△	82.9		DISTRICT WALLA WALLA
1-3	□	74.0		FINE AGGREGATE
1-4	⊗	52.2		N/A
1-5	▲	64.7		COARSE AGGREGATE
2-1	■	4.2	25	N/A

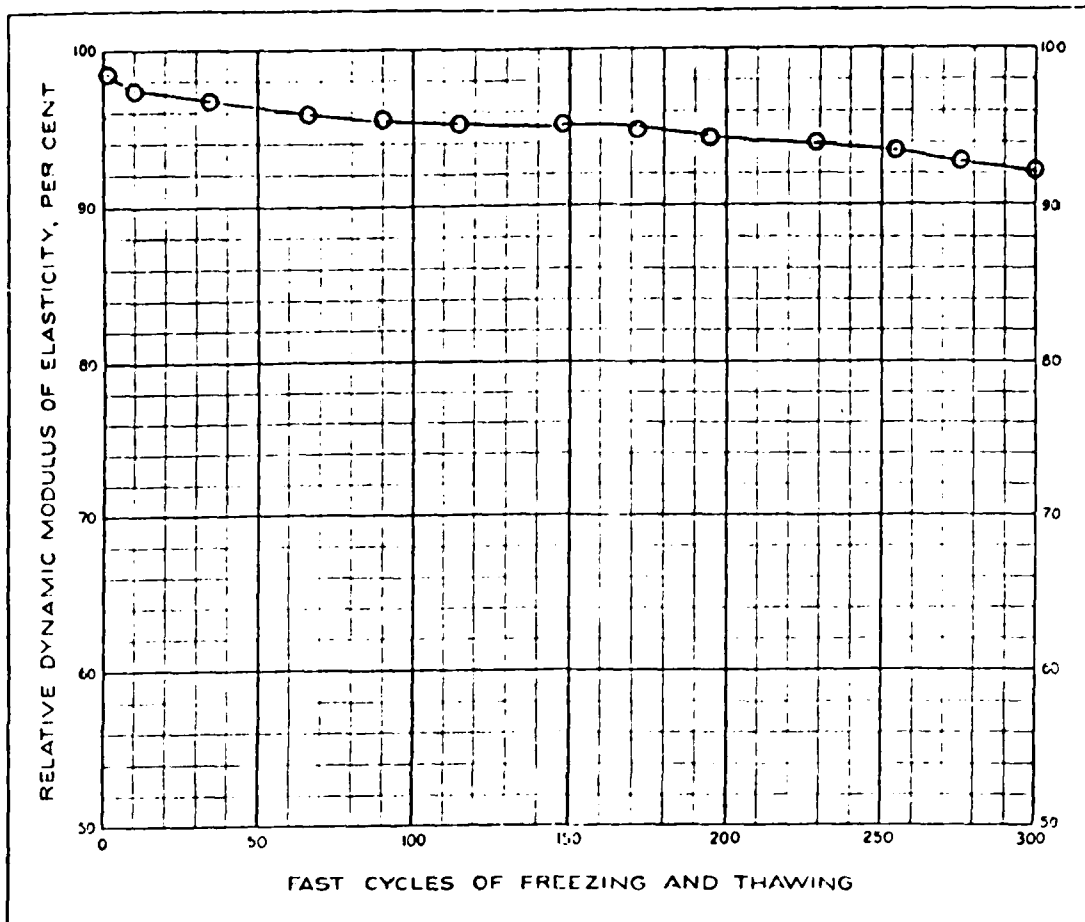
BEAM NO	SYMBOL	DPE AT 300 CYCLES	NO CYCLES REL E = 50%	PROJECT
311		92.9		<b>LOWER MONUMENTAL CONCRETE DURABILITY STUDIES</b> DISTRICT Walla Walla FINE AGGREGATE Laboratory processed natural sand, Mabels Pit, Snake River, WA COARSE AGGREGATE Laboratory processed natural gravel, Mathews Terrace, Snake River, WA
311 A		93.5		
311 B		90.6		
Average	○	92.3		
REMARKS Designed according to CRD-C 114, 3/4" MSA @ 0.49 W/C.				Plotted JP Checked W/O NO 77-C-5 James A. Paxton
RESISTANCE OF CONCRETE BEAMS TO ACCELERATED FREEZING AND THAWING CORPS OF ENGINEERS NORTH PACIFIC DIVISION TESTING LABORATORY

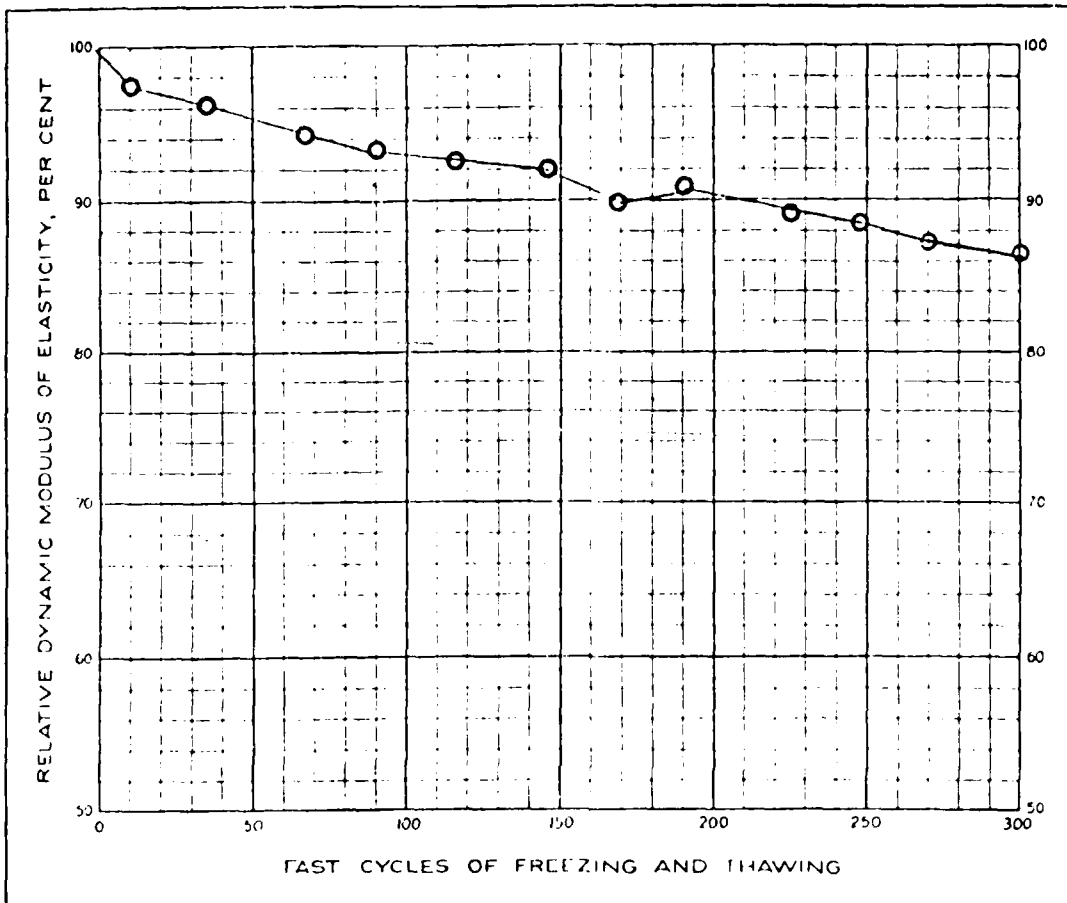
BEAM No.	Symbol	Def. at 100 Cycles	Def. at 300 Cycles	PROJECT
386		86.1		<b>LOWER MONUMENTAL CONCRETE DURABILITY STUDIES</b> DISTRICT <u>Walla Walla</u> FINE AGGREGATE Laboratory processed natural sand, Mabels Pit, Snake River, WA COARSE AGGREGATE Laboratory processed natural gravel, Mathews Terrace, Snake River, WA
386 A		88.1		
386 B		85.9		
Average	O	86.7		
REMARKS Cast from wet screened minus 3/4" portion of project Mix No. 3-5.25 P-2B. 30- Minute delay prior to casting.				Plotted <u>JP</u> W/O NO Checked _____ 77-C-5 James A. Paxton

TEST FORM 361 JUNE 1955	RESISTANCE OF CONCRETE BEAMS TO ACCELERATED FREEZING AND THAWING CORPS OF ENGINEERS NORTH PACIFIC DIVISION TESTING LABORATORY
----------------------------	--

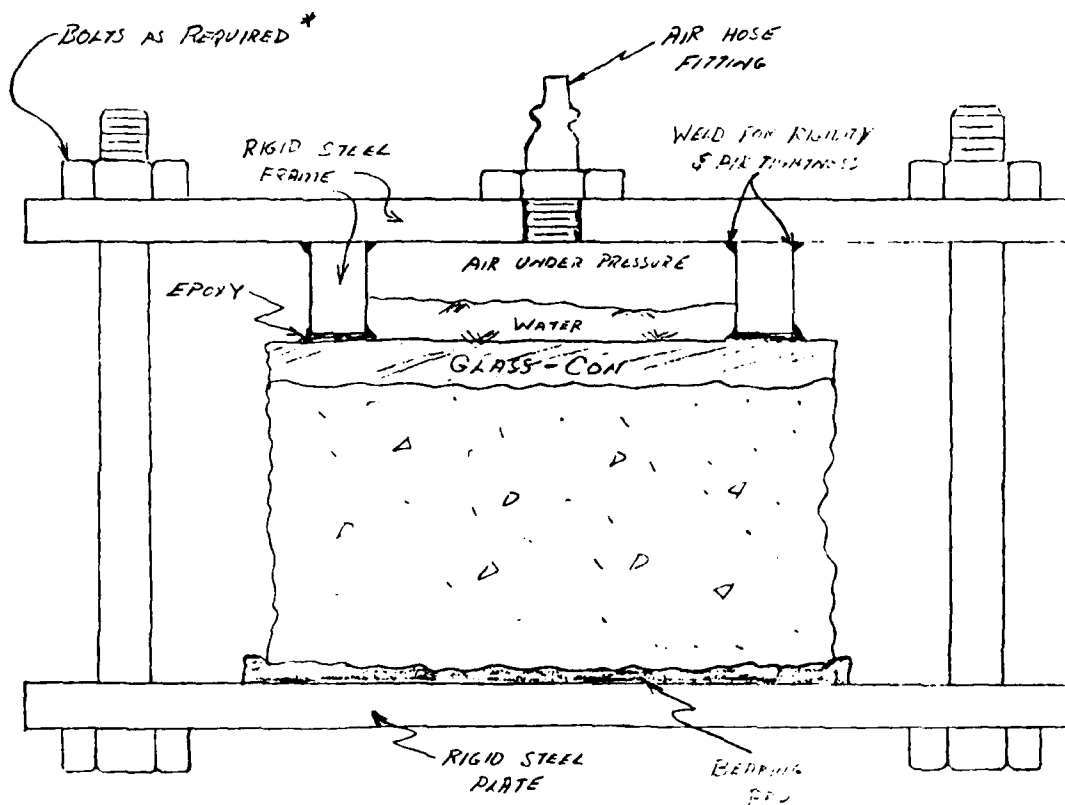
BY *EKS* DATE *6/25/76* SUBJECT *JIG FOR L-MANIPULATOR*  
 CHKD BY DATE *FACILE THE TEST OF*  
*GENS-CON SAMPLES*

\* CLAMP TOP AND BOTTOM PLATES TOGETHER. BOLTS SHOULD BE EVENLY TORQUED SO THAT THE FORCE ON THE EPOXY SEAL IS ZERO WHEN THE SYSTEM IS PRESSURIZED.

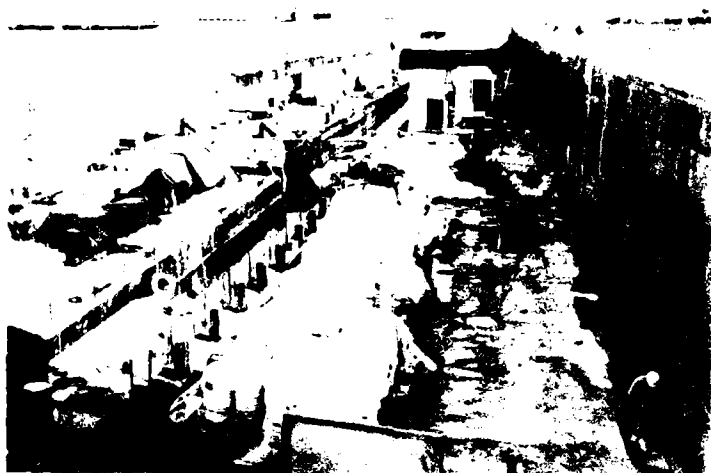
WORKING FROM BARGES TO APPLY THE LOCK WALL COATING NEAR THE UPPER LIFTS.

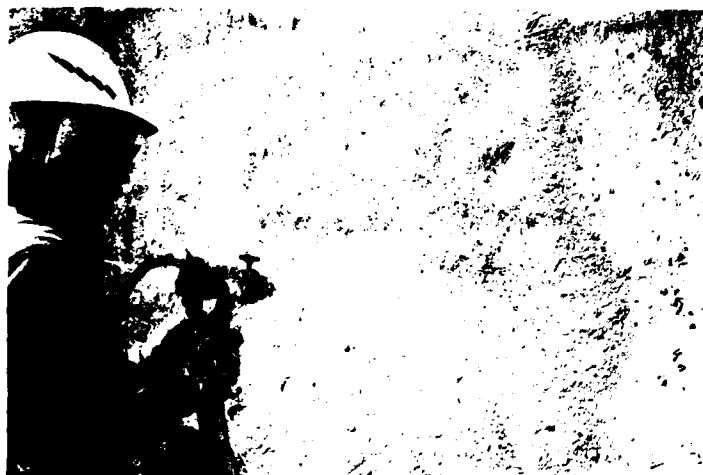
APPLYING THE MORTAR SIMULTANEOUSLY WITH THE FIBERGLASS FIBERS IN AN AREA OF MINIMAL SCALING NEAR THE TOP OF THE LOCK.

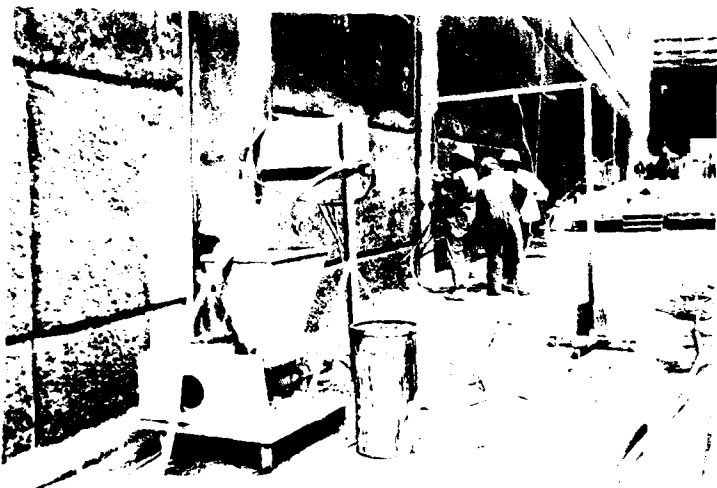
ONE OF THE FOUR SPRAY-UP UNITS. MORTAR IS BROUGHT FROM THE MIXER IN THE TUB AND DUMPED INTO THE GROUT PUMP. IT IS PUMPED THROUGH THE HOSE TO THE NOZZLE WHERE IT IS ATOMIZED AND SPRAYED ONTO THE WALL WHILE SIMULTANEOUSLY CUTTING THE FIBERS FROM A CONTINUOUS OVERHEAD STRAND AND BLOWING THEM ONTO THE WALL.

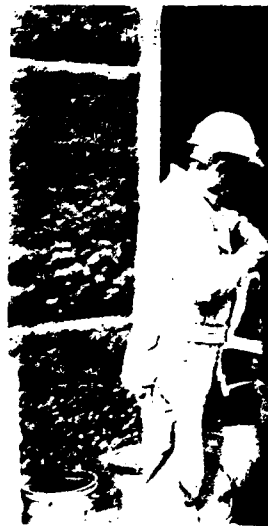
HIGH SHEAR MORTAR MIXER. THE GROUT PUMP TO THE RIGHT HAS THE CONTROLS COVERED WITH POLYETHYLENE SHEET. CEMENT IS STOCKPILED IN BACK.

TIMING THE MIX  
MORTAR MIXER

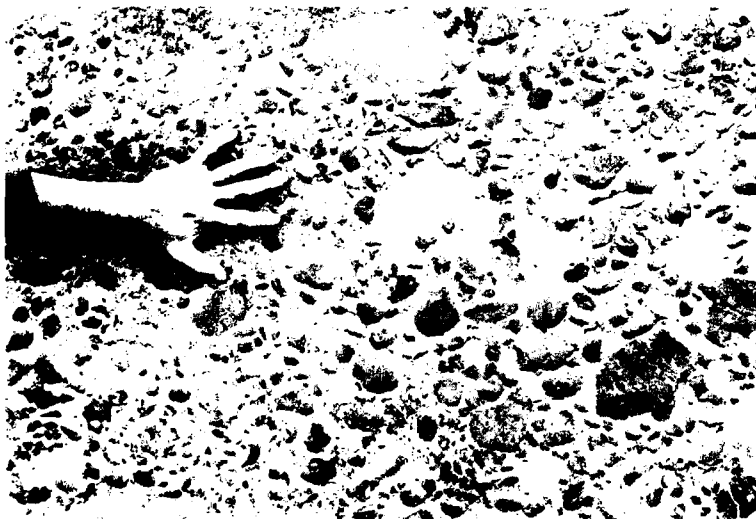
WALL SURFACE AFTER ACCEPTABLE SURFACE PREPARATION  
IN THE LOWER LIFTS.

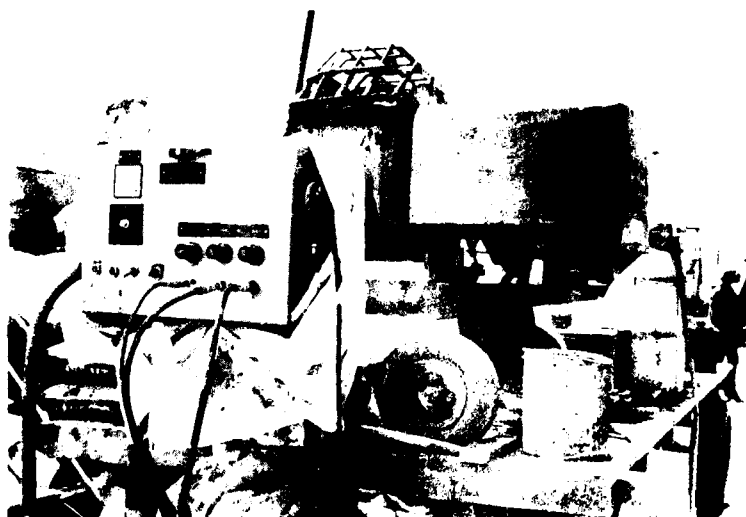
**MORTAR MIXER AND PUMP CONTROL BOARD.**

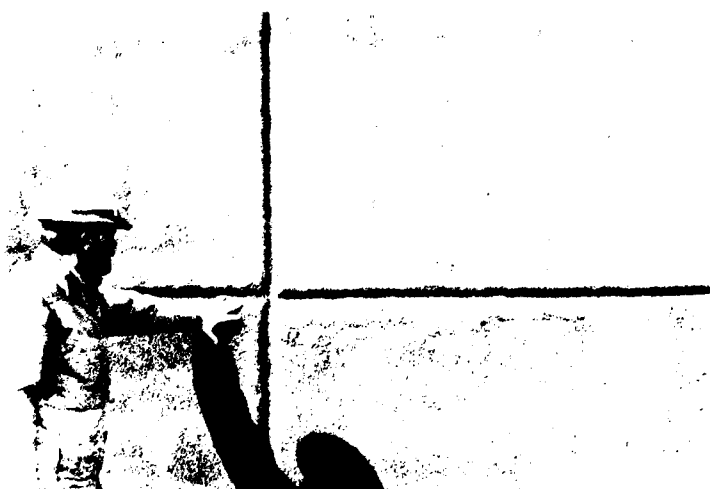
APPEARANCE OF THE WALL COATING IN THE UPPER LIFTS WHICH HAD MINIMAL DETERIORATION.
